# Manhole Inspection Summary

Manhole # S67U\_\_011MH

**Location** Address: **6224 Holabird Ave.**

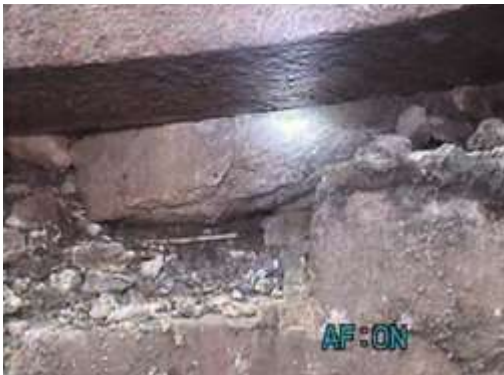
Defect 1

Condition: ☐ Sound ☐ Cracked ☐ Root Intrusion ☒ **Loose Brick** ☒ **Deteriorated**

Infiltration: ☐ None ☒ **Joint** ☐ Cracks ☒ **Mortar** ☐ Roots ☐ Wall

Loose bricks , and signs of infiltration in chimney

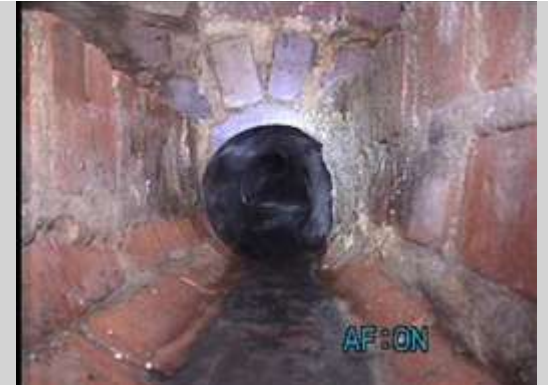
12 O'Clock Outflow

8 in. Circular Gravity Sewer  
Pipe Out @ 12 O'Clock

Pipe Height: **8.4** (in.) Rod and Bar (Angled)  
Pipe Material: **Clay** ☐ Pipe Lined  
Invert Depth: **7.83** (ft.) Flow Characteristics: **Fast**  
Deposits: ☒ None ☐ Mud ☐ Sludge ☐ **Debris** ☐ Grease  
Silt Depth: (in.) Deposits Extent:  
Infiltration: **None** Pipe Seal Cond: **Sound**

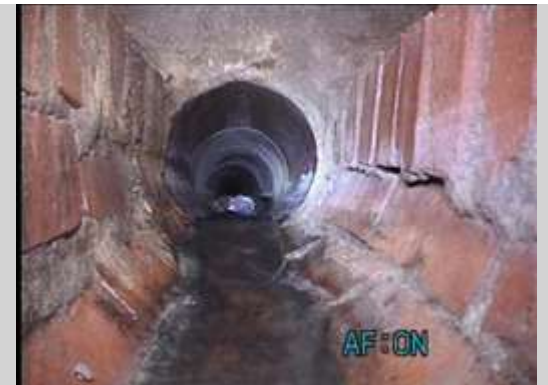
6 O'Clock Inflow

8 in. Circular Gravity Sewer  
Pipe In @ 6 O'Clock

Pipe Height: **8.4** (in.) Rod and Bar (Angled)  
Pipe Material: **Clay** ☐ Pipe Lined  
Invert Depth: **7.50** (ft.) Flow Characteristics: **Fast**  
Deposits: ☐ None ☐ Mud ☐ Sludge ☒ **Debris** ☐ Grease  
Silt Depth: **1.5** (in.) Deposits Extent: **Light**  
Infiltration: **None** Pipe Seal Cond: **Sound**
